A PRELIMINARY STUDY ON THE RESTORATION PROJECT OF ST. VINCENT DE FERRER CHURCH OF DUPAX DEL SUR: PROJECT IMPLICATION

Bobby U. Argote II

Department of Architecture, Saint Mary's University
Bayombong, 3700, Nueva Vizcaya, Philippines
bobby.argote2@gmail.com

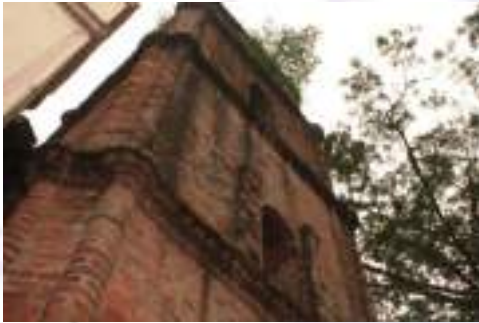
Plate 1. The four-tiered belltower as photographed from the ground with a tree and its roots clinging to the crevices of the brickwork.

- c. Removal of tree trunk, branch, roots and also grasses, moss and algae present in the brickwork (walls and buttresses).
- d. Cleaning and reconstructive work of architectural components.

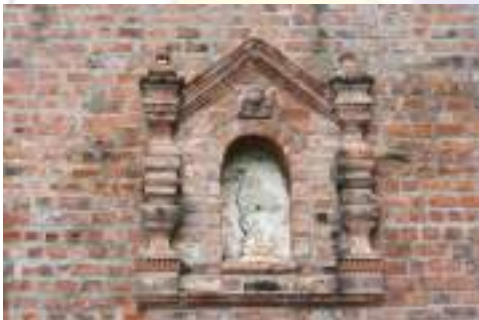
Plate 2. Detail of the belltower façade. The century old original image of the patron saint inside the arch was allegedly stolen.

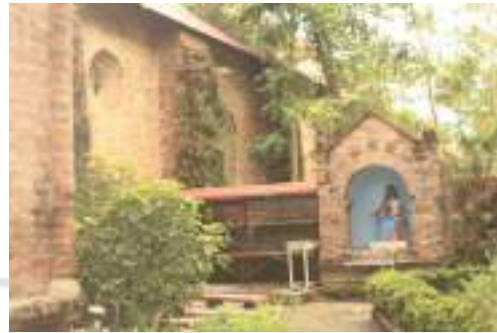
Plate 4. Support buttresses on the right side of the church where grass, algae and moss thrive on its outer face. Also shown is the area for grotto and candle lighting area for parishioners.

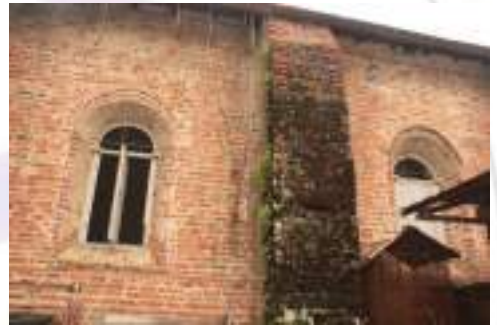
Plate 5. Dilapidated windows and a support buttress invaded by grass, moss and algae.

- e. Replacement of corrosive G.I. roofing sheets and application of protective paint film whenever possible.
- f. Reconstruction of damaged wooden doors and capiz shell windows (taking into consideration the original design and the materials used).

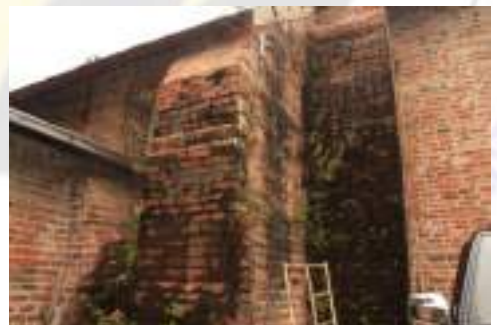
Plate 6. A support buttress covered in algae and moss. Upon closer look, water has already penetrated a portion of the core and slowly washing away the mortar and plaster that bind the bricks together.

- a. Disintegration and breaking down of existing building materials.
- b. Destruction of structural elements by tree's outgrown roots.
- c. Deterioration and weathering of architectural features such as mouldings, caps, etc.
- d. The presence of algae, moss and grasses clinging to the walls and exposed portion of the buttresses.
- e. Gradual breaking down of brick mortars due to water penetration – could lead

to deterioration of inner core of the massive walls (most old churches have no steel reinforcement and rely mostly on massiveness for strength).

- a. Cleaning, replacement and repair of damaged brickwork (including mortar and plaster).
- b. Removal of birds' droppings, nests and cleaning of affected areas.

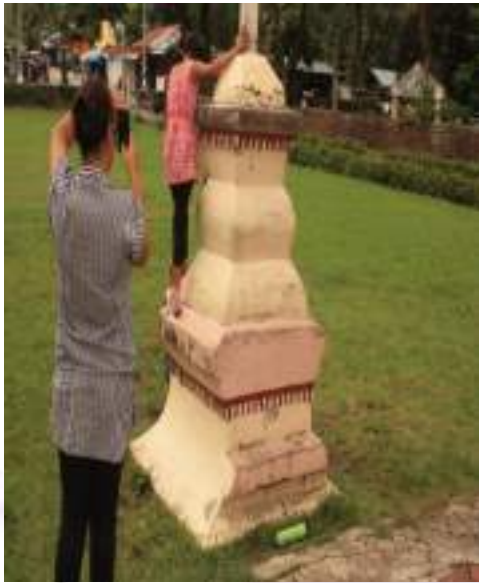
Plate 7. The crucifix tower originally at the highest point of the church, toppled down by the July 16, 1990 killer quake.

- g. Relocation of electrical service entrance including wiring.
- h. Provision of surrounding barrier at crucifix to fend off children and curious onlookers.

- i. Research, documentation and reconstruction of the crucifix's design including original wood specie.
- j. Provision of brass marker stating the history behind the fallen crucifix tower.

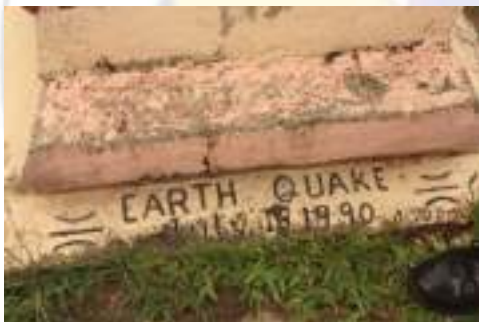
Plate 8. An improvised signage written in concrete plaster commemorating the exact time and date the earthquake occurred.

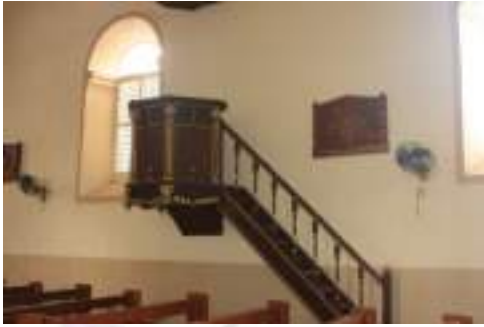
Plate 8. The elevated pulpit (*pulpito*) as seen from the altar. Originally, it was used by the priests before to deliver their sermon to the congregation.

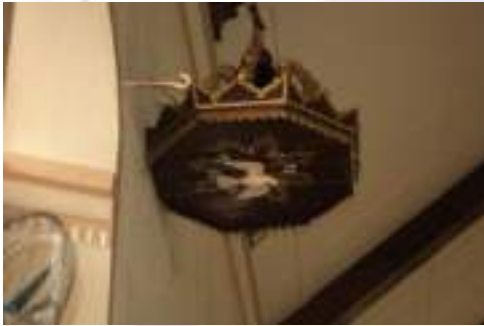
Plate 9. The detail of the pulpit's overhead cover. Paint is obviously peeling off and needs to be restored.

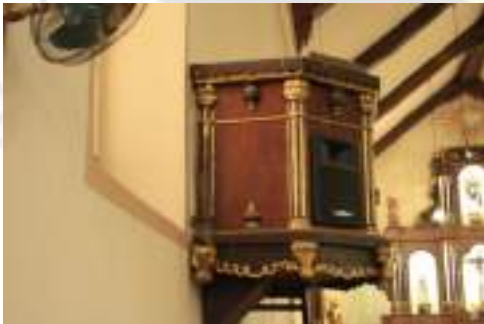
Plate 9. The pulpit panel, historically destroyed by the introduction of an electronic speaker in recent renovation works.

- a. Elevated pulpit
 - Loss of historical accuracy and integrity due to incorrect modification work of the elevated pulpit – installation of electronic speaker on pulpit panel.
- b. Identical stucco cladded columns (restored in 1996 by NCCA & National Museum)
 - Enlargement of cracks of the identical stucco cladded columns if left untreated.
 - The danger of plasters falling off that can harm parishioners.
 - Loss of heritage treasure.
- c. Floor tiles
 - Enlargement of cracks
 - Thinning of tile / appearance of crater due to wear and tear

- a. Removal of speaker.
- b. Reconstruction of pulpit panel and replacement of dilapidated elements taking into consideration the original design and material.
- c. Restoration of newly emerged cracks using the same material as the original and investigation of potential cracks on both columns (through x-ray if possible).
- d. Repair and replacement of broken and worn-out tiles.

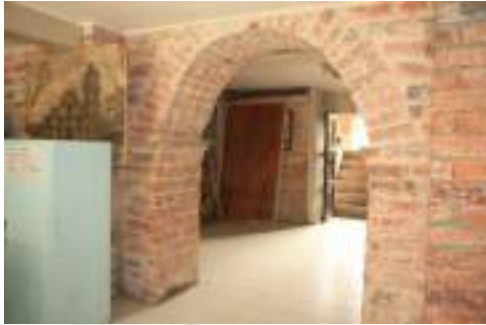
Plate 11. The arched brickwork entrance's keystone had been covered by the recent addition of ceiling. The original clay fired floor tiles have been replaced by modern ceramic tiles.

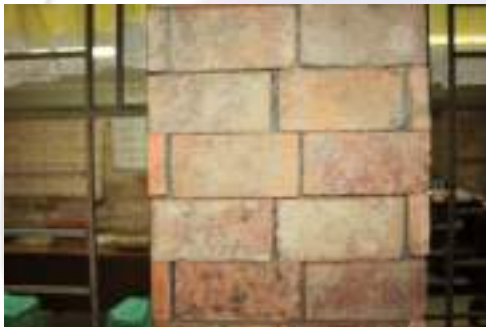
Plate 12. A column done with modern tools and procedures using the same brick as the chief material but mixed with concrete rather than stucco plaster. Resembles a modern decorative stone effect rather than reconstructing the original.

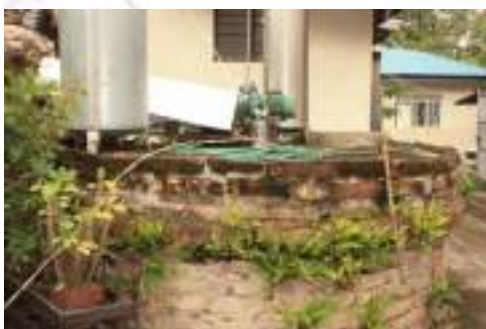
Plate 13. The old well (*bubon*) at the left side of the church, now covered with concrete slab and topped with electric water pumps, steel tanks cylinders and electrical wires.

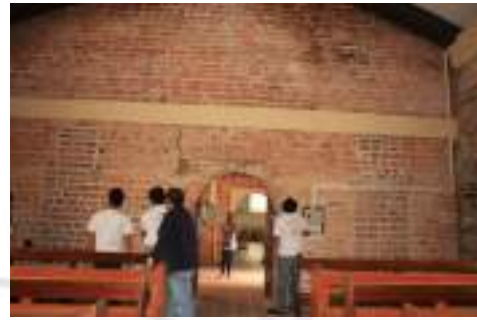
Plate 14. The interior wall of the Adoration chapel. The original location of windows are covered with bricks to recreate the same material but destroyed the uniformity of the brickwork pattern. Also shown is the exposed electrical wire moulding attached to the brick wall.
